# Manhole Inspection Summary

Manhole # S39C\_\_045MH

Insp Date: 1/15/08 1:59 PM

**Location** Address: **low st**

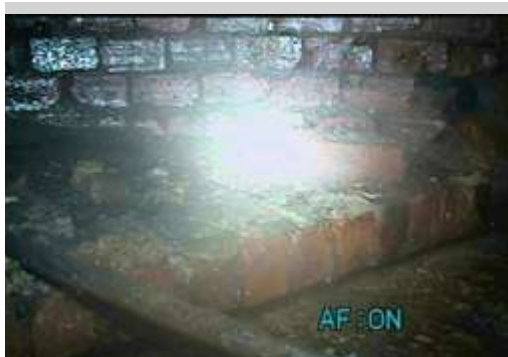
Defect 5

Condition: ☐ Sound ☐ Cracked ☐ Root Intrusion ☐ Deteriorated ☐ Leaks ☒ **Debris**

bench debris

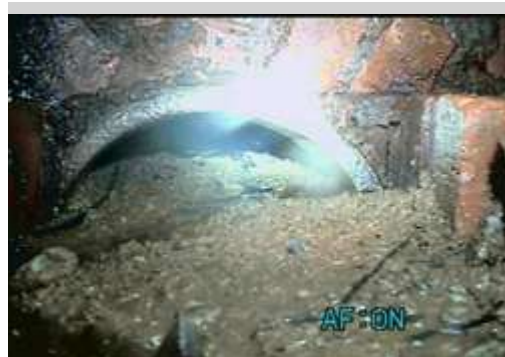
Defect 4

Condition: ☐ Sound ☐ Cracked ☐ Root Intrusion ☐ Deteriorated ☐ Leaks ☒ **Debris**

channel debris

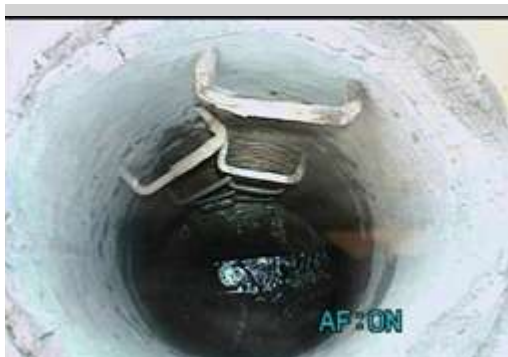
Defect 3

Count: **8** Missing: **0** ☒ **Corroded**

steps

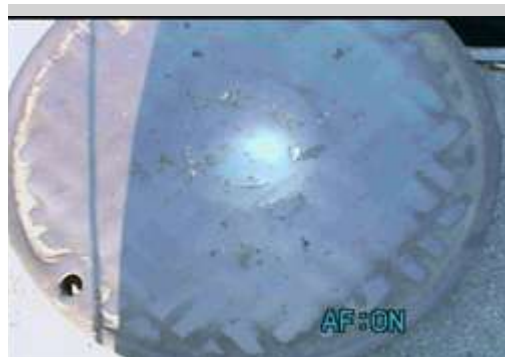
Defect 2

Condition: **Worn**

worn cover

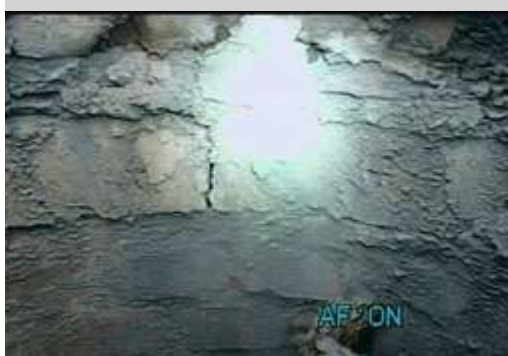
### Defect 1

Condition: ☐ Sound ☒ **Cracked** ☐ Root Intrusion ☐ Loose Brick ☒ **Deteriorated**

cracked and detrriorated chimney, frame  
adj

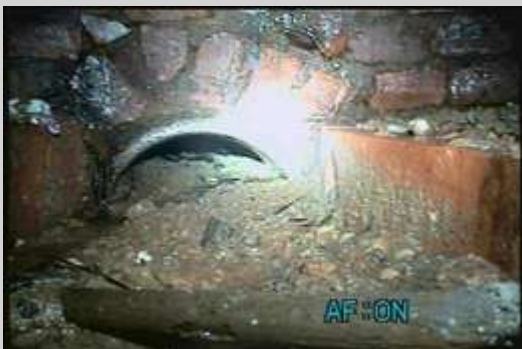
3 O'Clock Inflow

Deposits: ☐ None ☐ Mud ☐ Sludge ☒ **Debris** ☐ Grease

Silt Depth: 5 (in.) Deposits Extent: **Heavy**

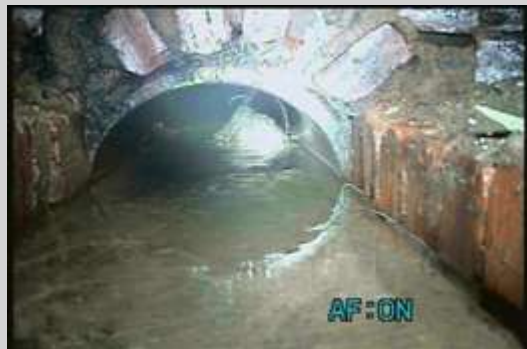
6 O'Clock Inflow

Deposits: ☐ None ☐ Mud ☐ Sludge ☒ **Debris** ☐ Grease

Silt Depth: **1** (in.) Deposits Extent: **Light**
